Meeting of the Hawke's Bay Regional Council

Date: Wednesday 26 August 2020
Time: 11.00am
Venue: Council Chamber
Hawke's Bay Regional Council
159 Dalton Street
NAPIER

Subject: FOLLOW-UP ITEMS FROM PREVIOUS REGIONAL COUNCIL MEETINGS

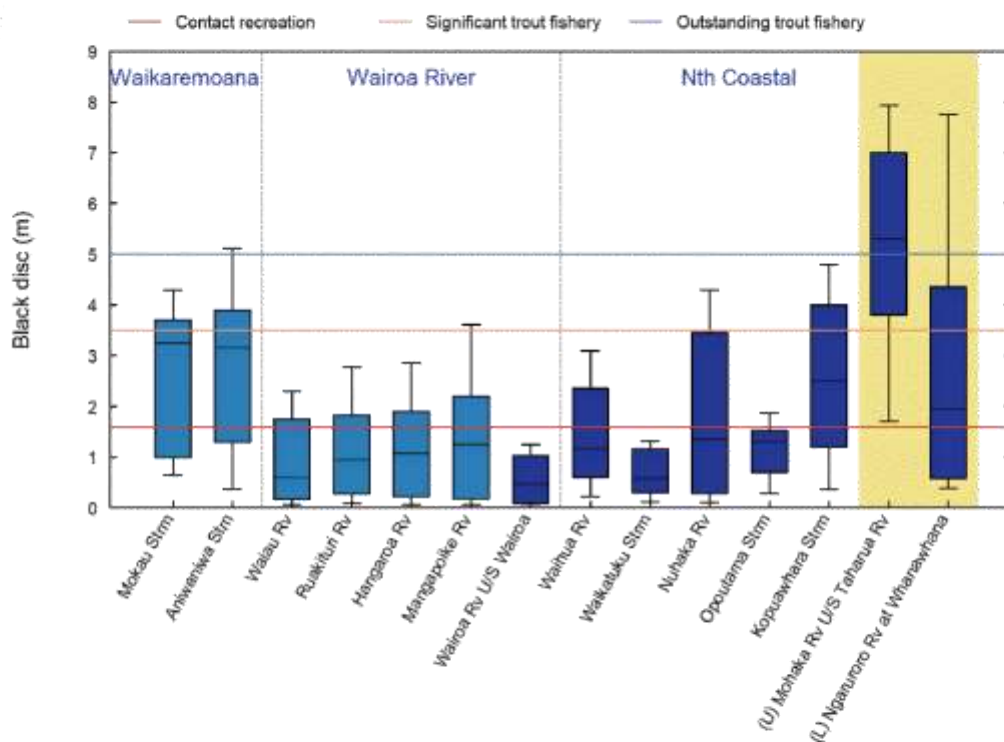
Figure 2-9: Boxplots of black disc (water clarity) for the Wairoa and nearby coastal catchments. The horizontal lines are guidelines for contact recreation and trout fisheries. Yellow shading identifies Hawke's Bay upland (U) and Lowland (L) reference sites for comparison.

In general, water clarity at Northern subregion monitoring sites is degraded, with median black disc sighting distances at nine of the twelve sites less than the guideline for recreational waters (Figure 2-9).

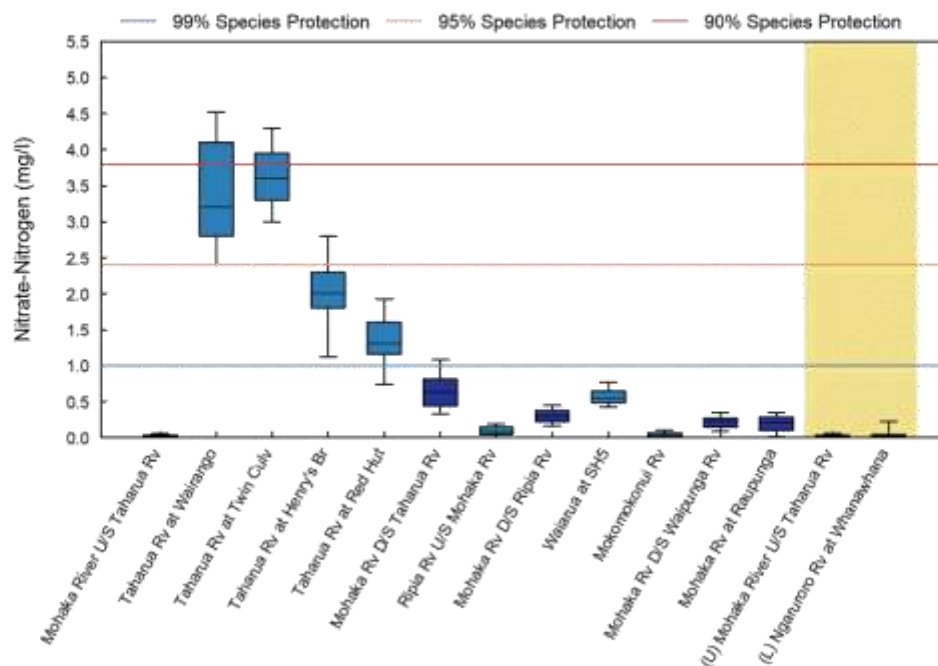
Figure 2-12: Nitrate-nitrogen ($\text{NO}_3\text{-N}$) levels at Mohaka monitoring sites. SoE sites for the Mohaka River U/S Taharua confluence and the Ngaruroro River at Whanawhanga (shaded yellow) are included as Upland (U) and Lowland (L) reference sites for comparison purposes. The blue, orange and red lines relate to nitrate toxicity limits for 99%, 95% and 90% species protection respectively. The proposed NOF bottom line for nitrate toxicity is 95% species protection.

Furthermore, nitrate-nitrogen levels at two sites in the Taharua subcatchment fail the proposed NOF bottom line for nitrogen toxicity, which is proposed to achieve 95% species protection (Figure 2-12).

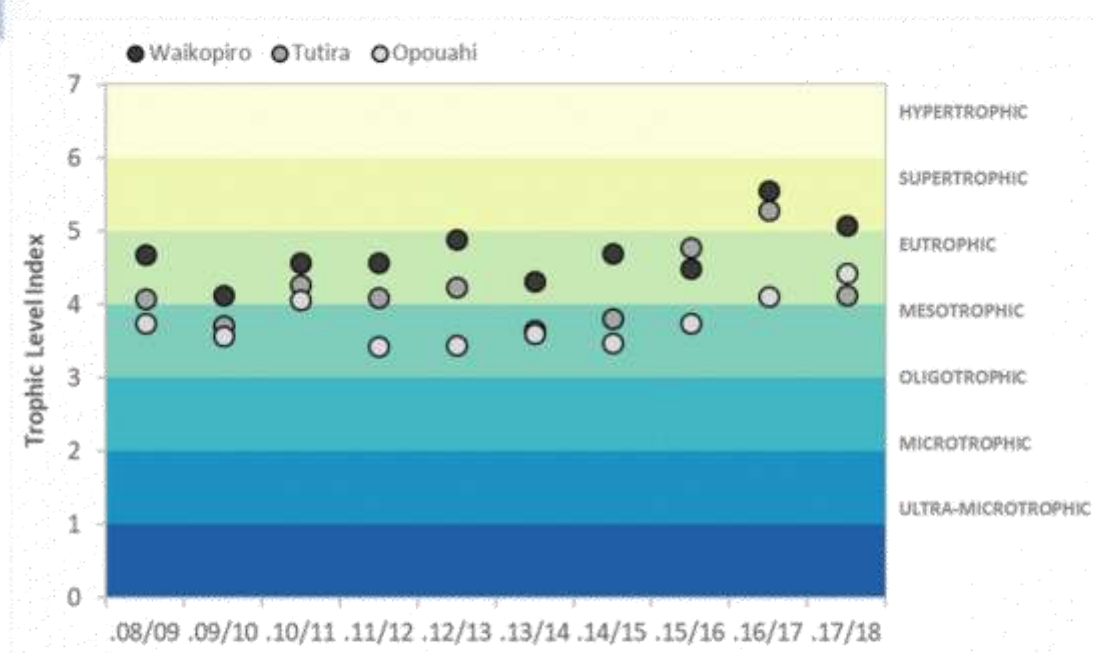
Figure 2-20: Trophic Level Index (TLI) for Lake Tūtira, Lake Opouahi and Lake Waikōpiro. Data are from July 2008 to June 2018.

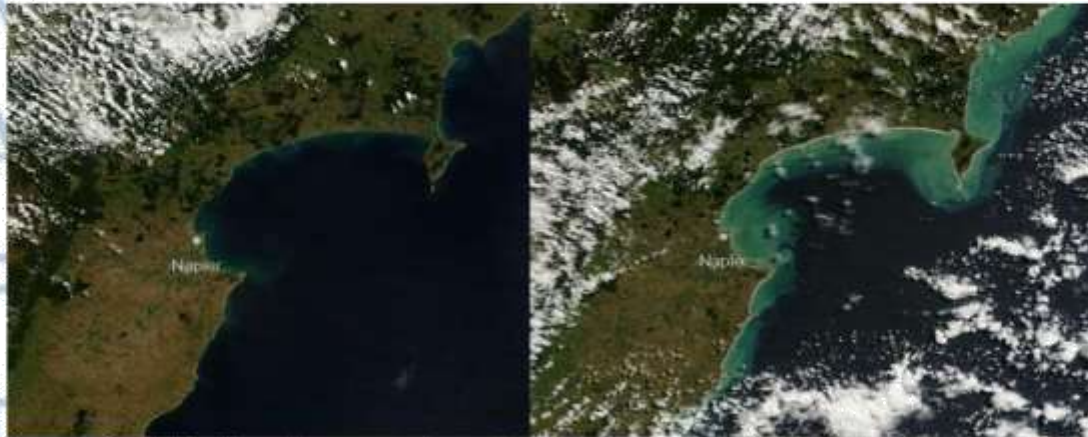
Figure 2-22: The influence of a rain event on turbidity in the Hawke Bay Coastal Marine Area. Satellite imagery shown: (left) prior to Cyclone Pam; and (right) after Cyclone Pam in March 2015.

As noted in section 2.1.2a), the Northern subregion is particularly susceptible to land erosion and there are large land areas that deliver high sediment yields (Figure 2-2), with more than 55% of the region's sediment load coming from these catchments. The fate of sediment in waterways is ultimately to coastal receiving environments including estuaries, nearshore coastal areas and the marine environment in extreme cases (Figure 2-22).

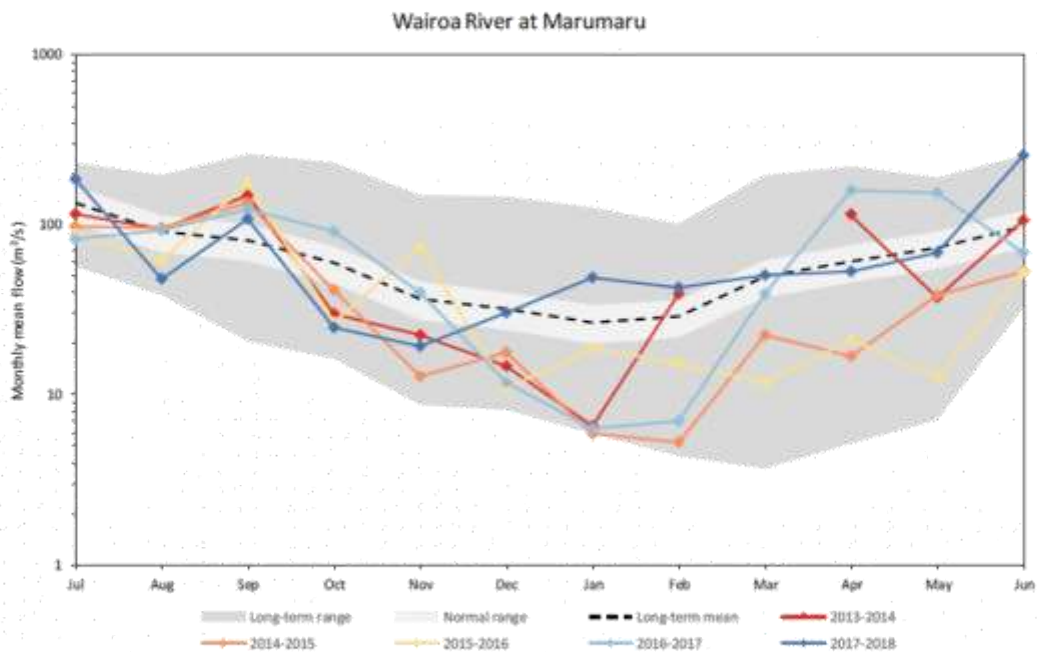
Figure 2-26: Wairoa River at Marumaru monthly mean flow. Annual time series' from 2013-2014 to 2017-2018 are shown with the long-term mean, long-term range and normal range (1980-2018).

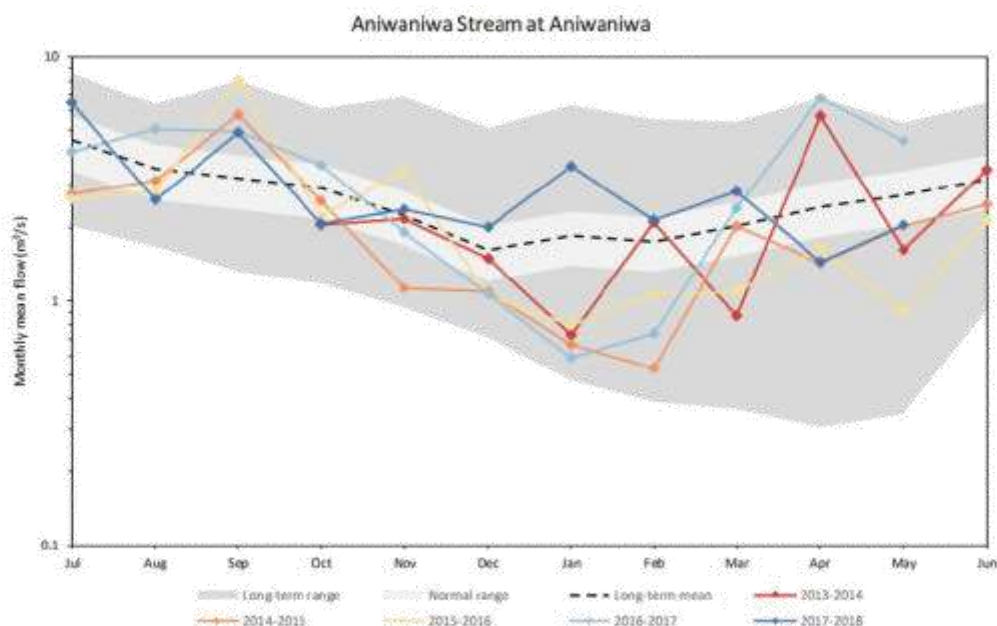
Figure 2-29: Aniwikiwa Stream at Aniwikiwa monthly mean flow. Annual time series' from 2013-2014 to 2017-2018 are shown with the long-term mean, long-term range and normal range (1980-2018).

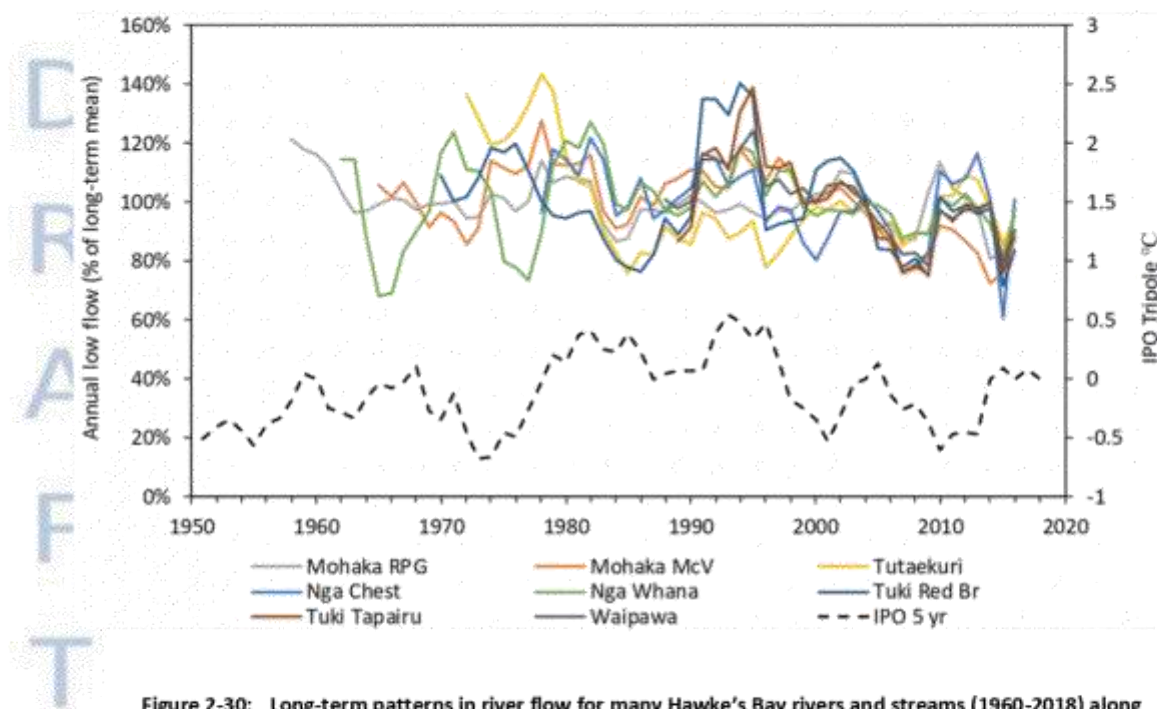
Figure 2-30: Long-term patterns in river flow for many Hawke's Bay rivers and streams (1960-2018) along with IPO Tripole. River flows are presented here using a 5-year moving average of the 7-day annual low flow time series'. Flows are standardized by the long-term mean for each site so rivers of different size can be compared directly. Climate drivers are compared using the dashed black line (right Y-axis), which represents the 5-year moving average IPO Tripole (Interdecadal Pacific Oscillation Tripole index).

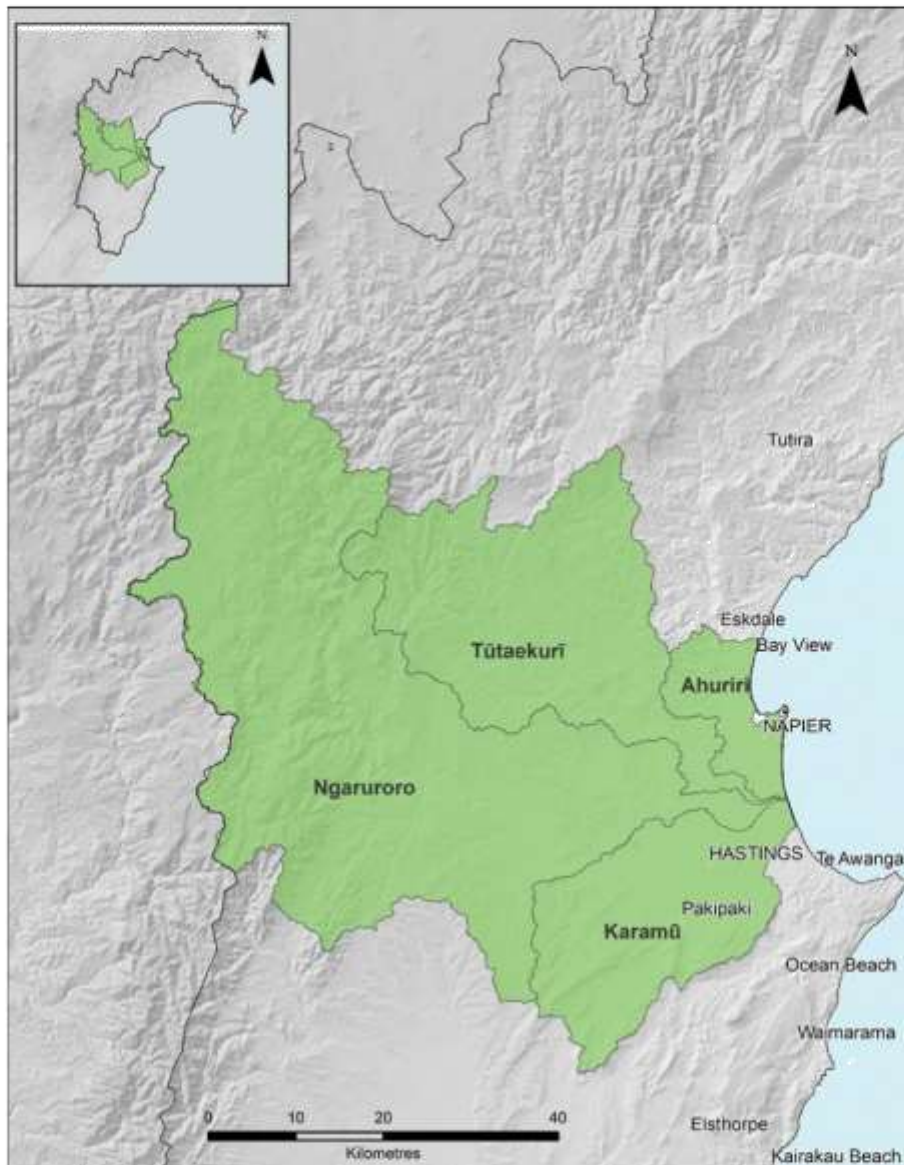
Figure 3-1: Locations of TANK catchments and their position within the Hawke's Bay regional boundary (inset).

The Heretaunga subregion has four main catchments: the Tūtaekurī, Ahuriri, Ngaruroro and Karamū, which are collectively known as the TANK catchments (Figure 3-1).

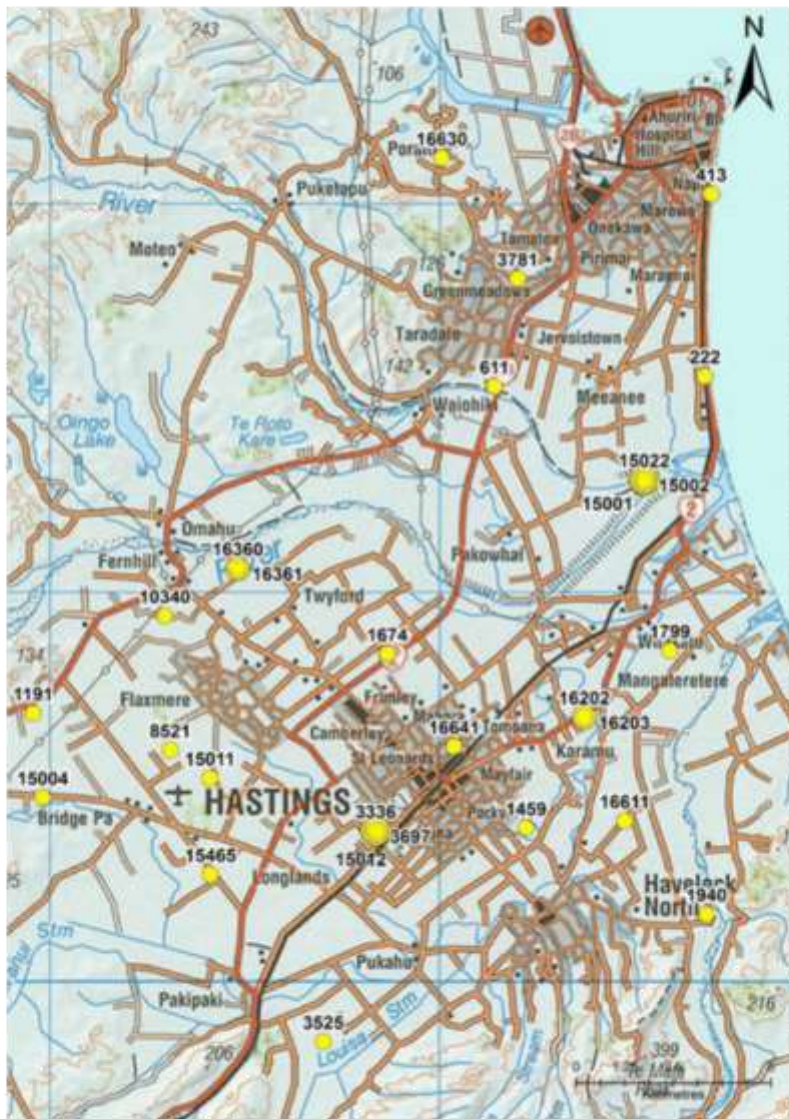
Figure 3-3: Heretaunga Plains bores used for monitoring groundwater quality. Bore numbers are shown next to yellow circles that show the location.

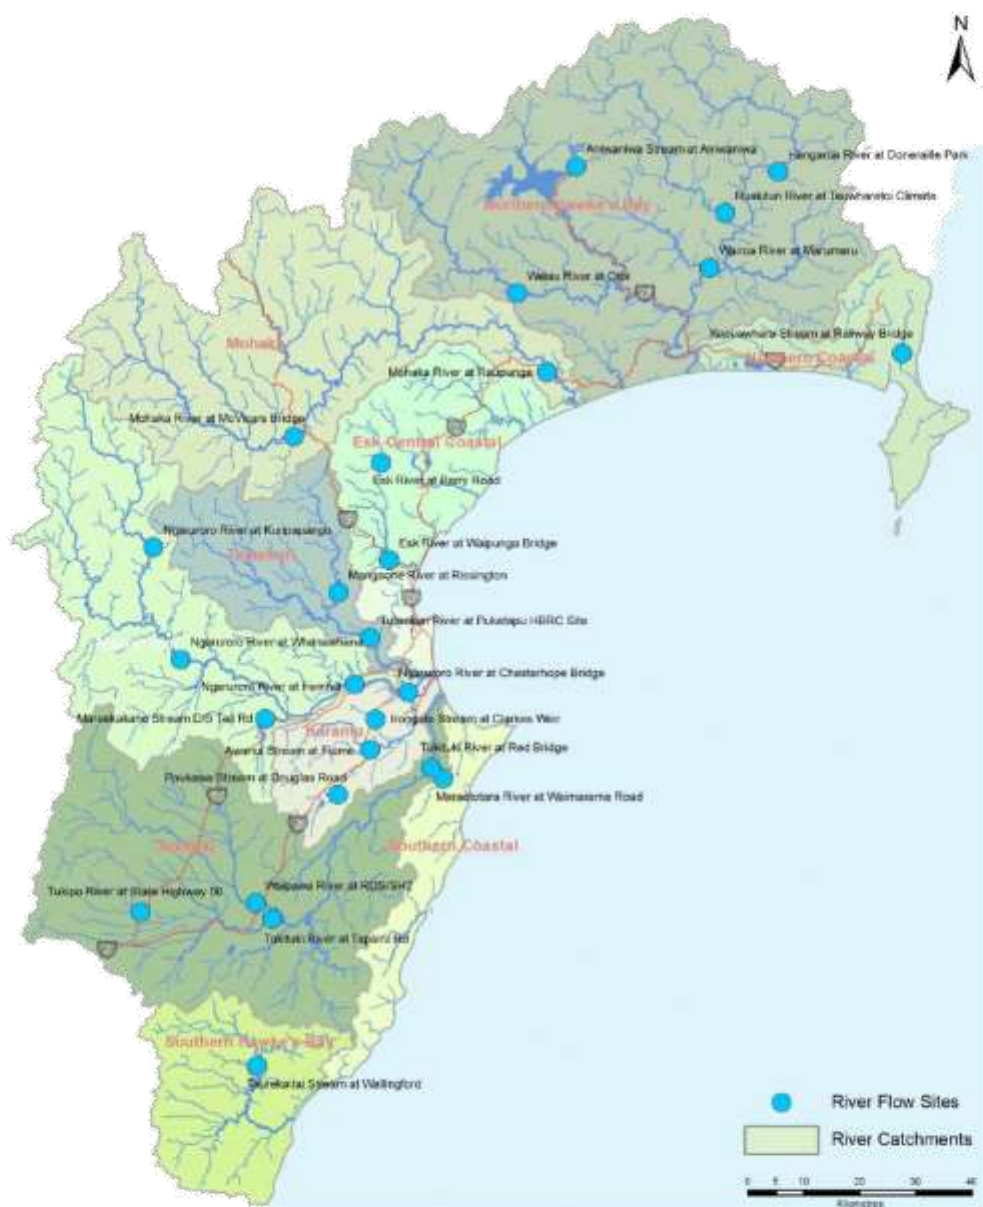
Figure 3-21: Locations of long-term SoE river flow monitoring sites.

A range of summary river flow statistics were calculated for Heretaunga catchments for the hydrological years⁷ 2013-2014 through to 2017-2018 and for the available long-term record. The locations of State of the Environment river flow sites in Hawke's Bay are shown in Figure 3-21.

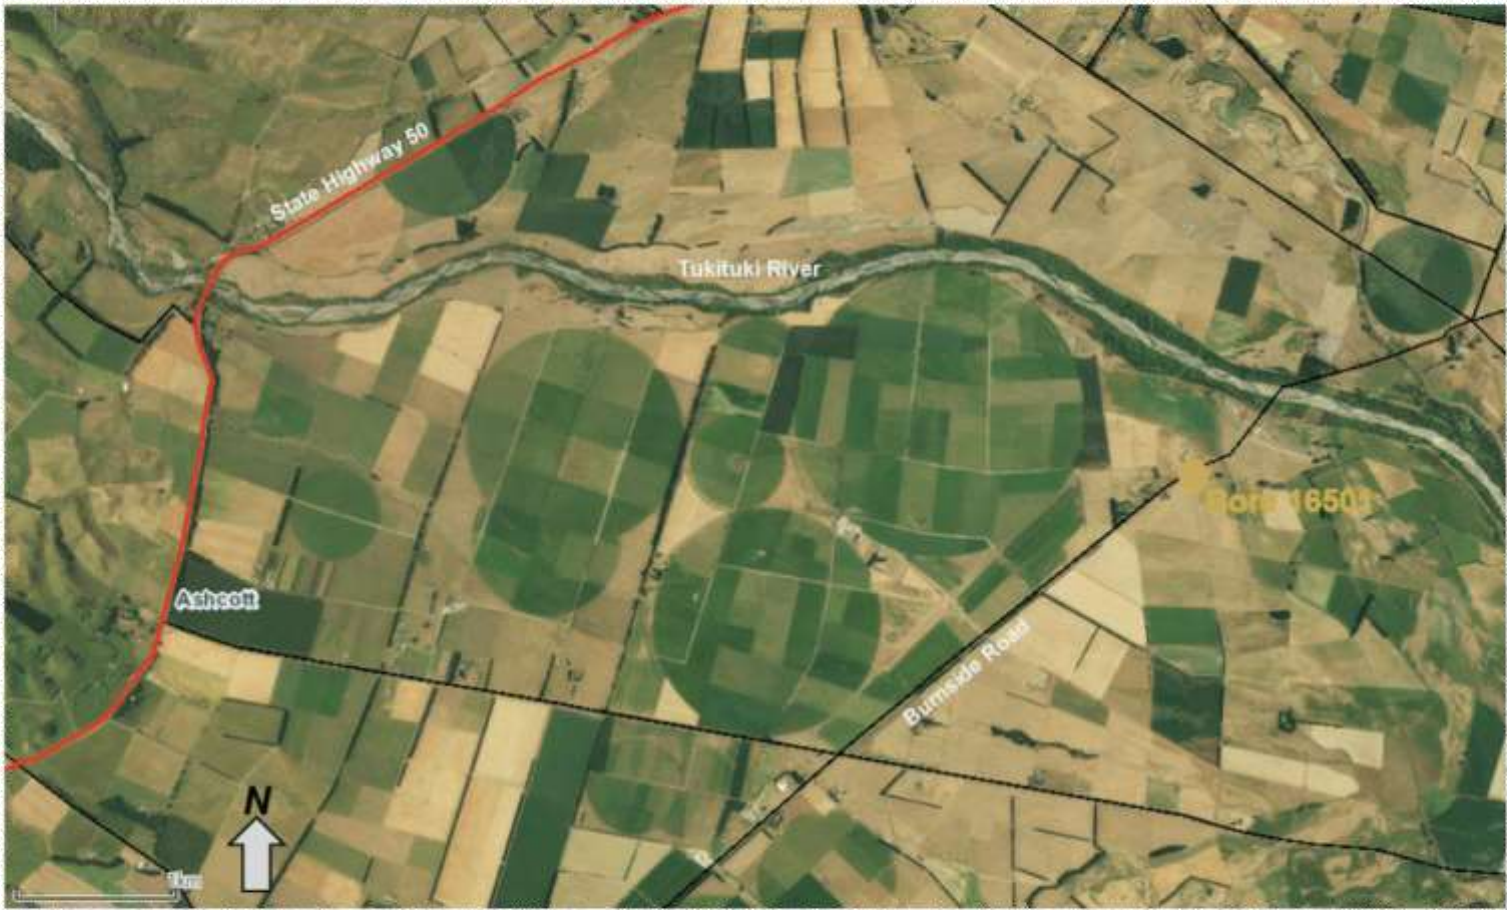
Figure 4-6: Location of monitoring bore number 16501.

Bore 16501 is a shallow (16m below ground) well that is downgradient of a large dairy farming operation (Figure 4-6). It is likely that the source of nitrate at bore 16501 is related to land use activities in the area.

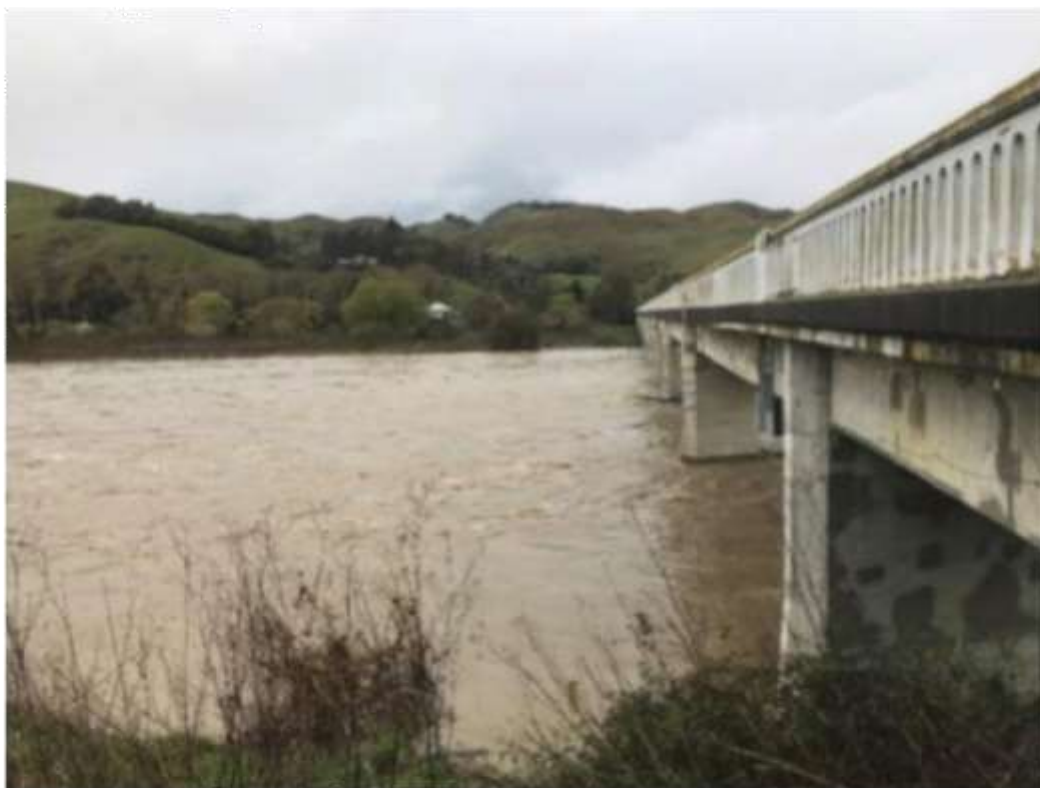
Figure 4-16: Tukituki River at Red Bridge during the September 2018 flood event.

The installation of an auto-sampler in the Tukituki River at Red Bridge has captured suspended sediment concentrations at a range of flows (Figure 4-15), including an event in September 2018 with peak flow 1,407 m³/s having a 1-in-5 year recurrence interval (Figure 4-16). Using results from the auto-sampler, total sediment load in the Tukituki River was estimated at 386,000 tonnes during this one event from 4-10 September 2018. Along with degrading instream water quality and habitat, this fine sediment is ultimately deposited in estuarine and coastal environments, with adverse effects on those habitats and ecosystems

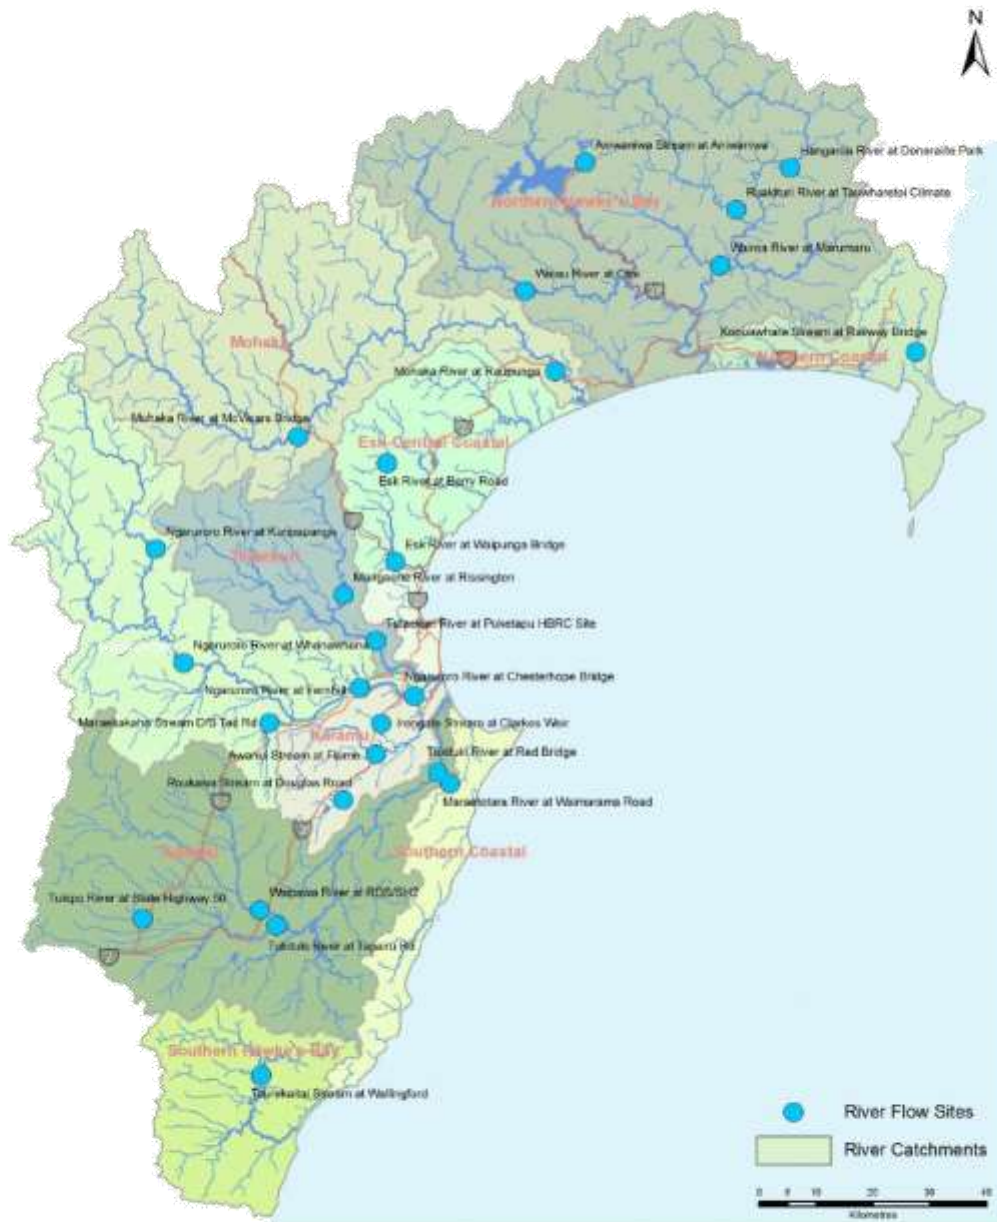
Figure 4-29: Locations of Hawke's Bay SoE river flow monitoring sites.

A range of summary river flow statistics were calculated for the Tukituki and Southern Coastal catchments for the hydrological years¹⁰ 2013-2014 through to 2017-2018 and for the available long-term record. The locations of State of the Environment river flow sites in Hawke's Bay are shown in Figure 4-29.
