HAWKES BAY REGIONAL COUNCIL

Meeting of the Cyclone Recovery Committee

Subject: MANAAKI WHENUA - RAPID ASSESSMENT OF LAND DAMAGE

Review of Hawkes Bay Regional Council telemetry system

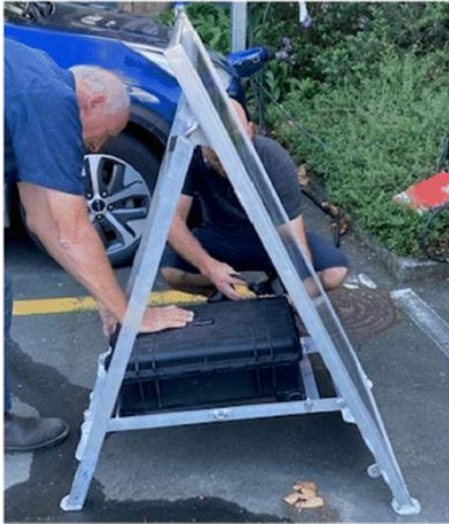
equipment. As a back-up HBRC have purchased a portable repeater that can be easily transported and set up anywhere. (photo below)

An option is for HBRC is to establish their own LMR repeater or invest in a portable repeater. A battery/charging system to power the LMR repeater would be required in the instance of mains failure (if mains power were supplied at a secondary repeater).
