## Regional Council Workshop

Item	Title	Page
<b>3.</b>	<b>Heretaunga Plains and Upper Tukituki Cyclone Gabrielle scheme reviews</b>	
Attachment 1:	Heretaunga Plains Flood Control Scheme Review update 31 July 2024 presentation	2
Attachment 2:	Upper Tukituki Flood Control Scheme Review update 31 July 2024 presentation	39

# Heretaunga Plains Flood Control Scheme Reviews

# Upper Tukituki Flood Control Scheme Review

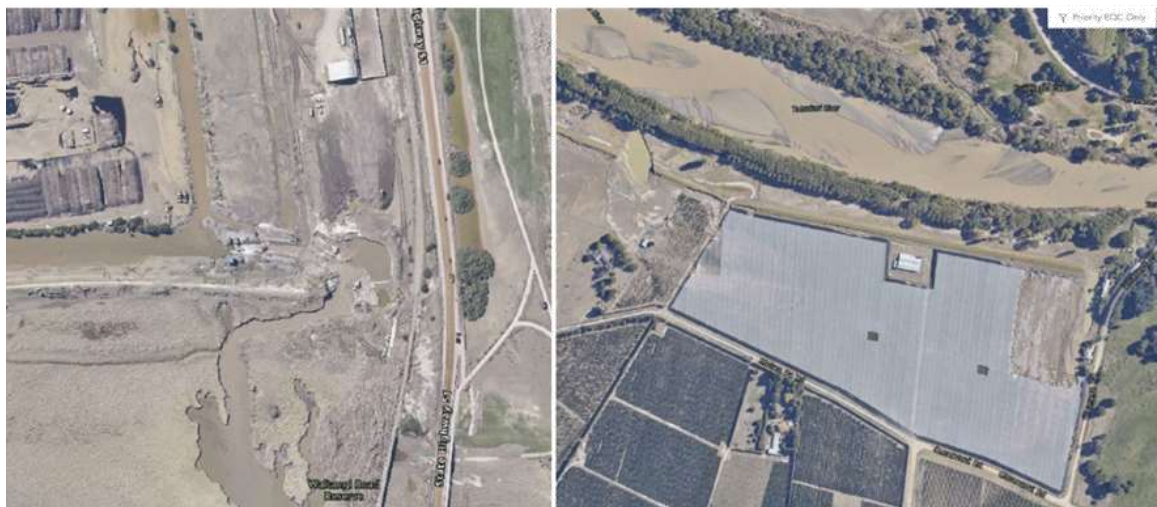
## Scheme performance - Channel Fairway & Berms

- Overall performance of the channel fairway, bank protection, and buffer vegetation, was very good given the scale of the flood event.
- Aside from breach sites-river bank & berm erosion was negligible. Stopbank erosion on riverside batter slopes only occurred in unusual circumstances i.e. Pakowhai & Taradale.
- The concept of a clear channel fairway of adequate & uniform width, bounded by vegetation buffer zones, and with adequate berm separation to stopbanks, was well proven.

### Bridges

- Tutaekuri River Bridges such as Puketapu, Redclyffe, and Brookfields, as well as the Rail and SH51 Waitangi Bridges, all trapped substantial volumes of woody debris.
- They also caused waterway obstruction, and contributed to increased stopbank overflow and breach.
- In practice the bridges, although owned & maintained by authorities other than HBRC, are key elements of the HPFCS.

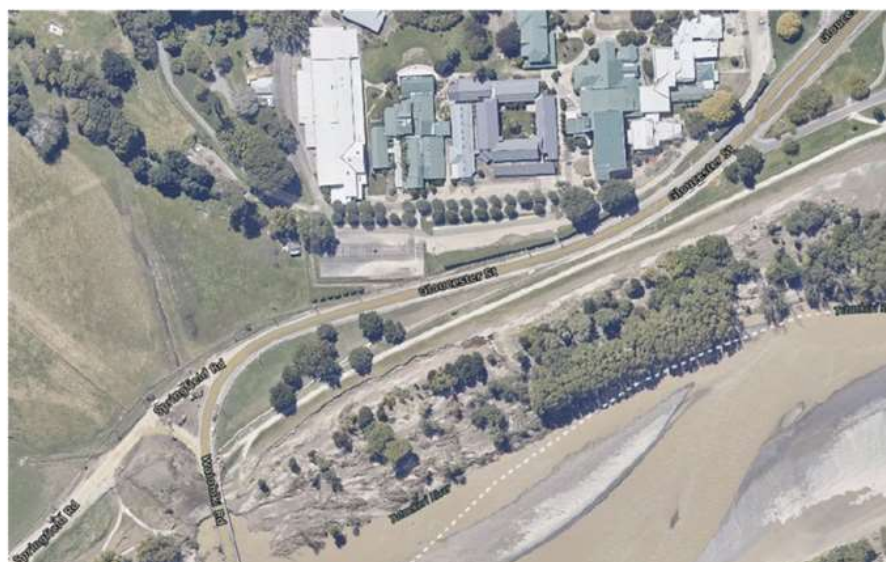
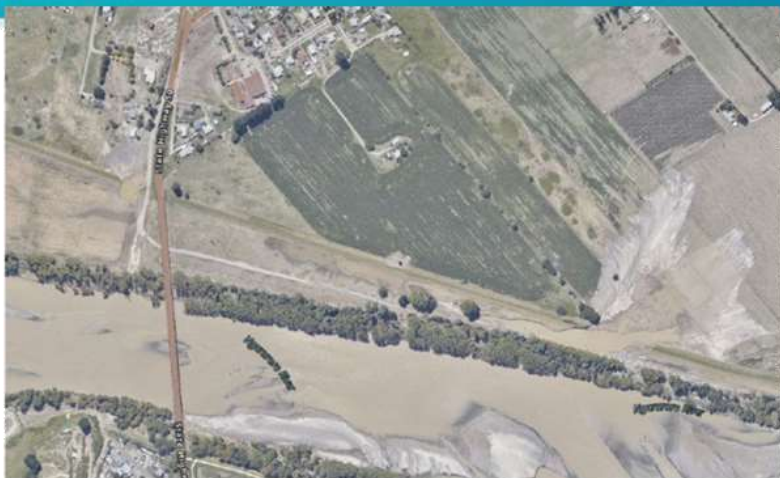
A number of breaches and scours were noted in Heretaunga, including:

### Tutaekuri

- Major breaches at Moteo and Dartmoor leading to inundation along Swamp Rd.
- Scour and breaches at Omarunui section.
- Major breaches and scour of Ebbets stopbank (private)
- Major breach at Awatoto leading to inundation of industrial area and Napier WWTP
- Out of channel flows into Waiohiki community (no stopbanks present).
- Scour on toe of Taradale Stopbank (recently upgraded to 0.2%AEP). Water was at crest level of new bank.

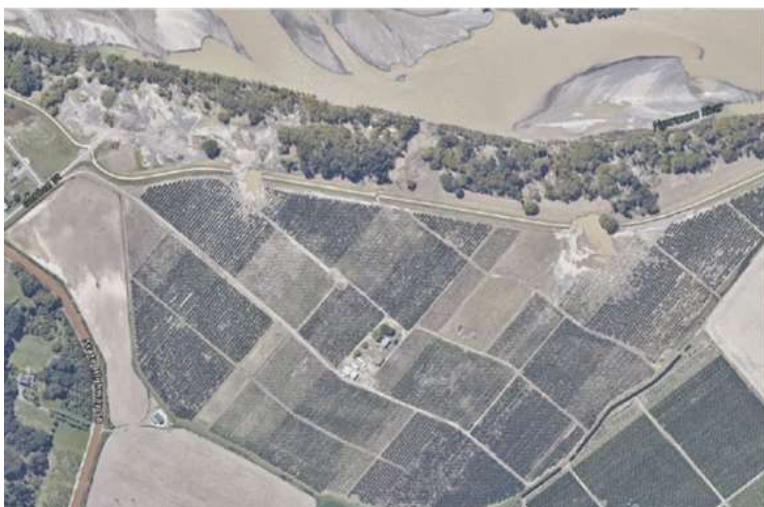
### Ngaruroro

- Breaches on small stopbanks at Ohiti Rd
- 5 breaches and 20 overtopping scours at Omahu to Fernhill (the overtopping was effectively all the way to SH2 expressway)
- Failure at Confluence (overtopped from landward side)
- Scour and 2 breaches at Raupere section.
- Minor scours and overtopping at Lower Raupere section
- Overtopping and scour damage at Farndon Rd.

### Lower Tukituki

- No damage noted and flood levels were contained within stopbanks.
- Berm scour at Tennants Rd deflection access ramp

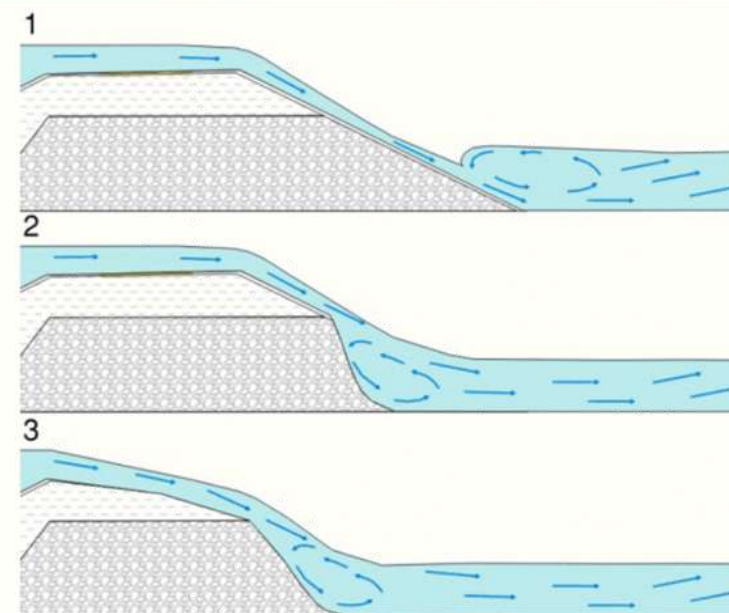
Figure 9- A schematic diagram showing the progression of overtopping to scour to eventual breach.

- Most of the Heretaunga stopbanks comprise gravel core with silt overlay.
- Most breach sites were clearly as a result of overtopping and headward erosion/scour developing into full breach.
- A handful of sites may have had some level of piping failure associated (around old penetrations). However, this is still likely a secondary failure mode.
- **In summary, the current stopbank geometry is vulnerable to erosion**

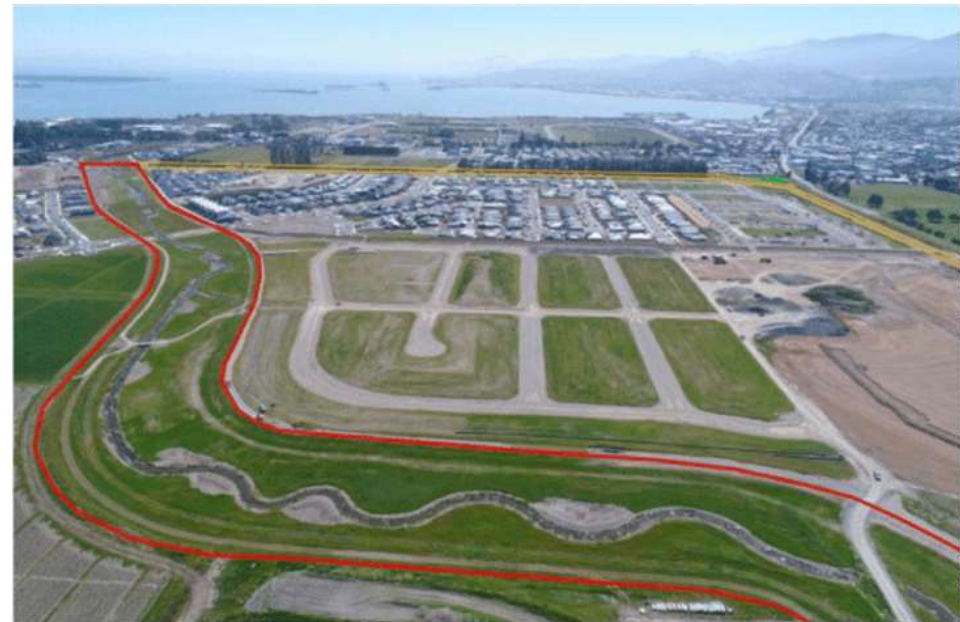
## Moteo floodway concept- NZ examples

- NZ precedent. Lower Manawatu scheme (Moutoa)
- Borck Creek – Nelson/Richmond –much smaller scale
- Oporua floodway – Lower Wairarapa Valley Development Scheme
- McPhails floodway – Waipaoa River Flood Control Scheme

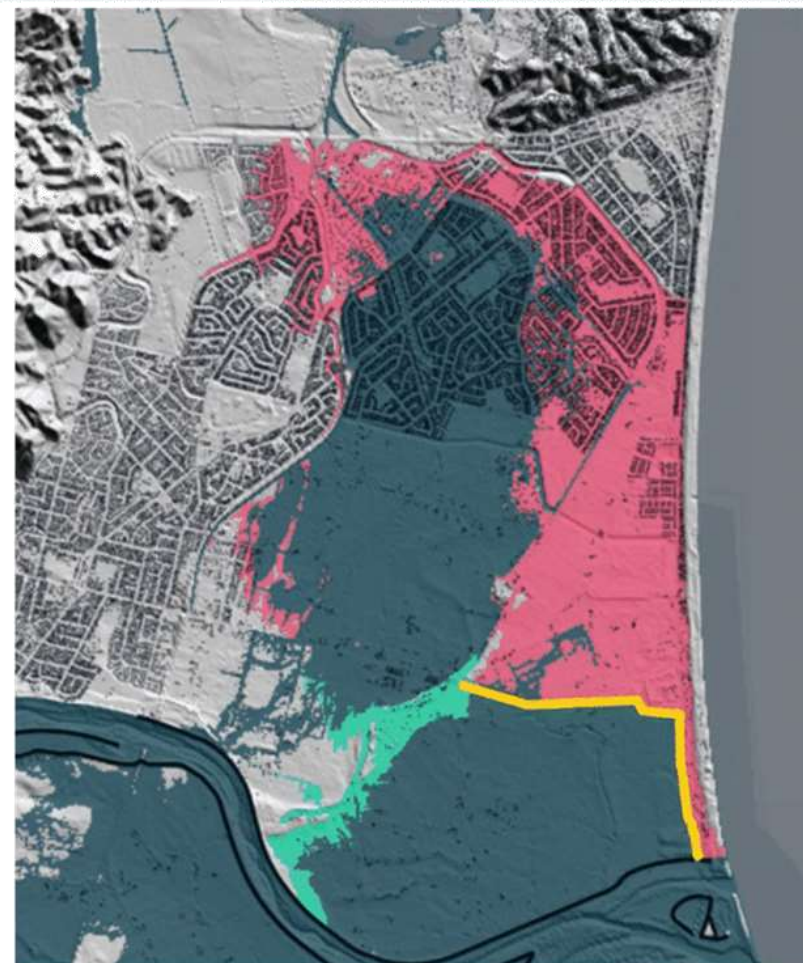
## Awatoto Secondary bank option

- Secondary stopbank (approx. 2m high) to protect industrial area and south Napier area.
- Appears to be outflanked through Meanee in large events but does provide improvement
- Could be expanded with further secondary banking to further improve resilience.

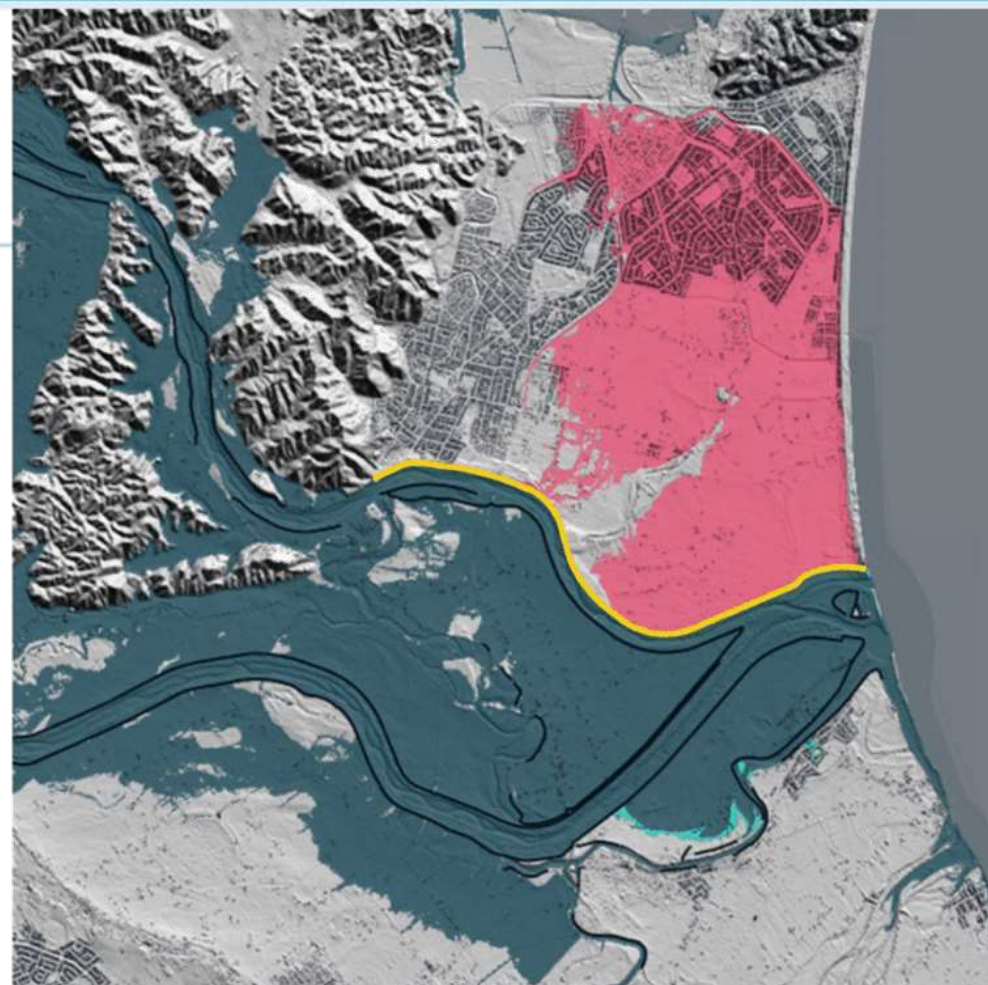
## Taradale-Awatoto stopbank raise option

- Appears to be effective in managing 500 yr event with minimal adverse effects.
- Stopbanks will need to be raised significantly (circa 1-2m). Will require careful design and seepage controls.
- Does not provide redundancy or secondary protection.
- Road and rail crossings at mouth would need to be raised significantly.

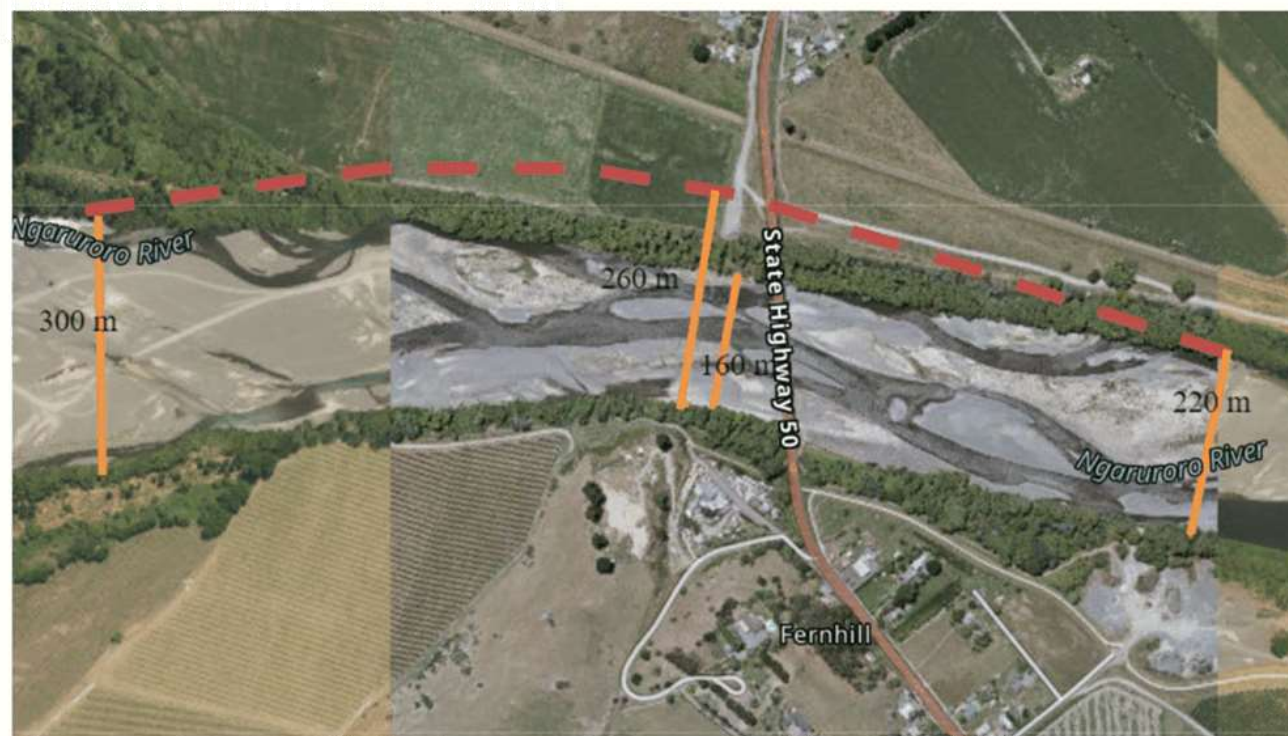
## Omahu Section- channel alignment

- Opportunity to widen channel fairway, & increase river & bridge waterway capacity at Fernhill/Omahu.
- Need to confirm bridge pile depth adequacy & new rock lining/channel design requirement.

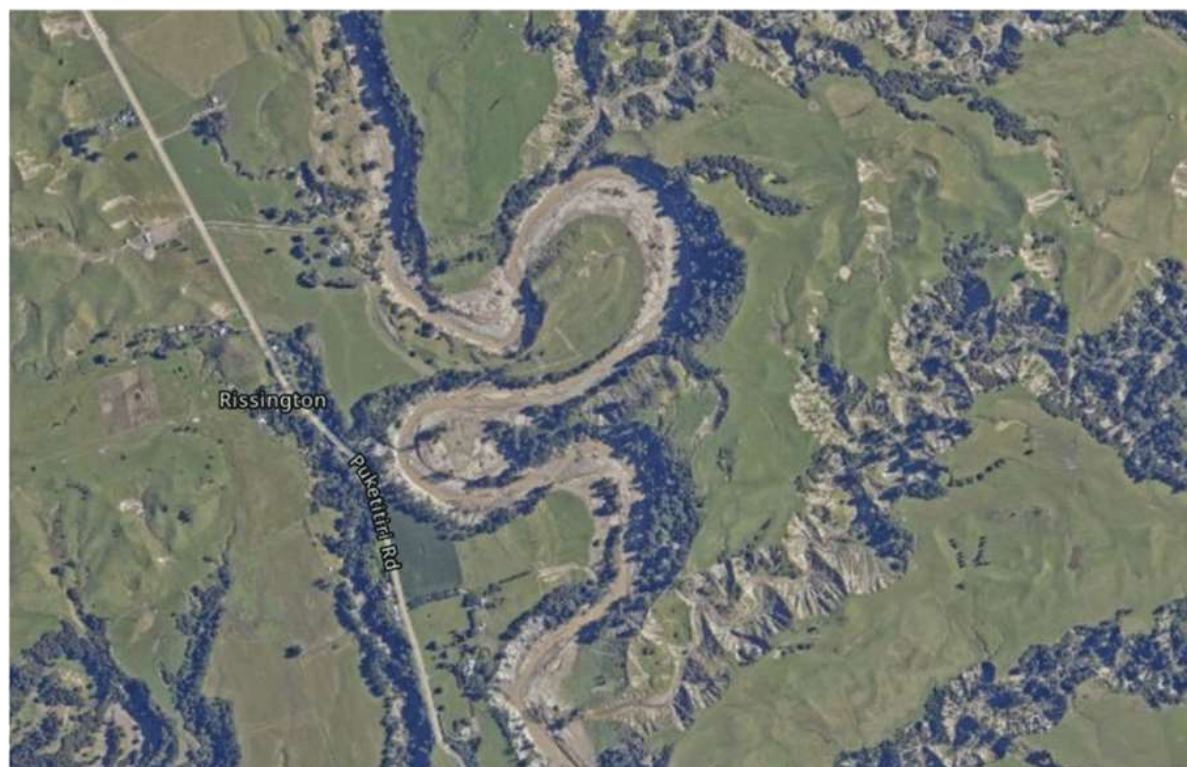
- Reduced woody debris input from riparian margins.
- Woody debris capture at strategic locations? Improved forestry management?
- Gully erosion in upper Tutaekuri near Rissington. Typical of upper-mid catchment land use.

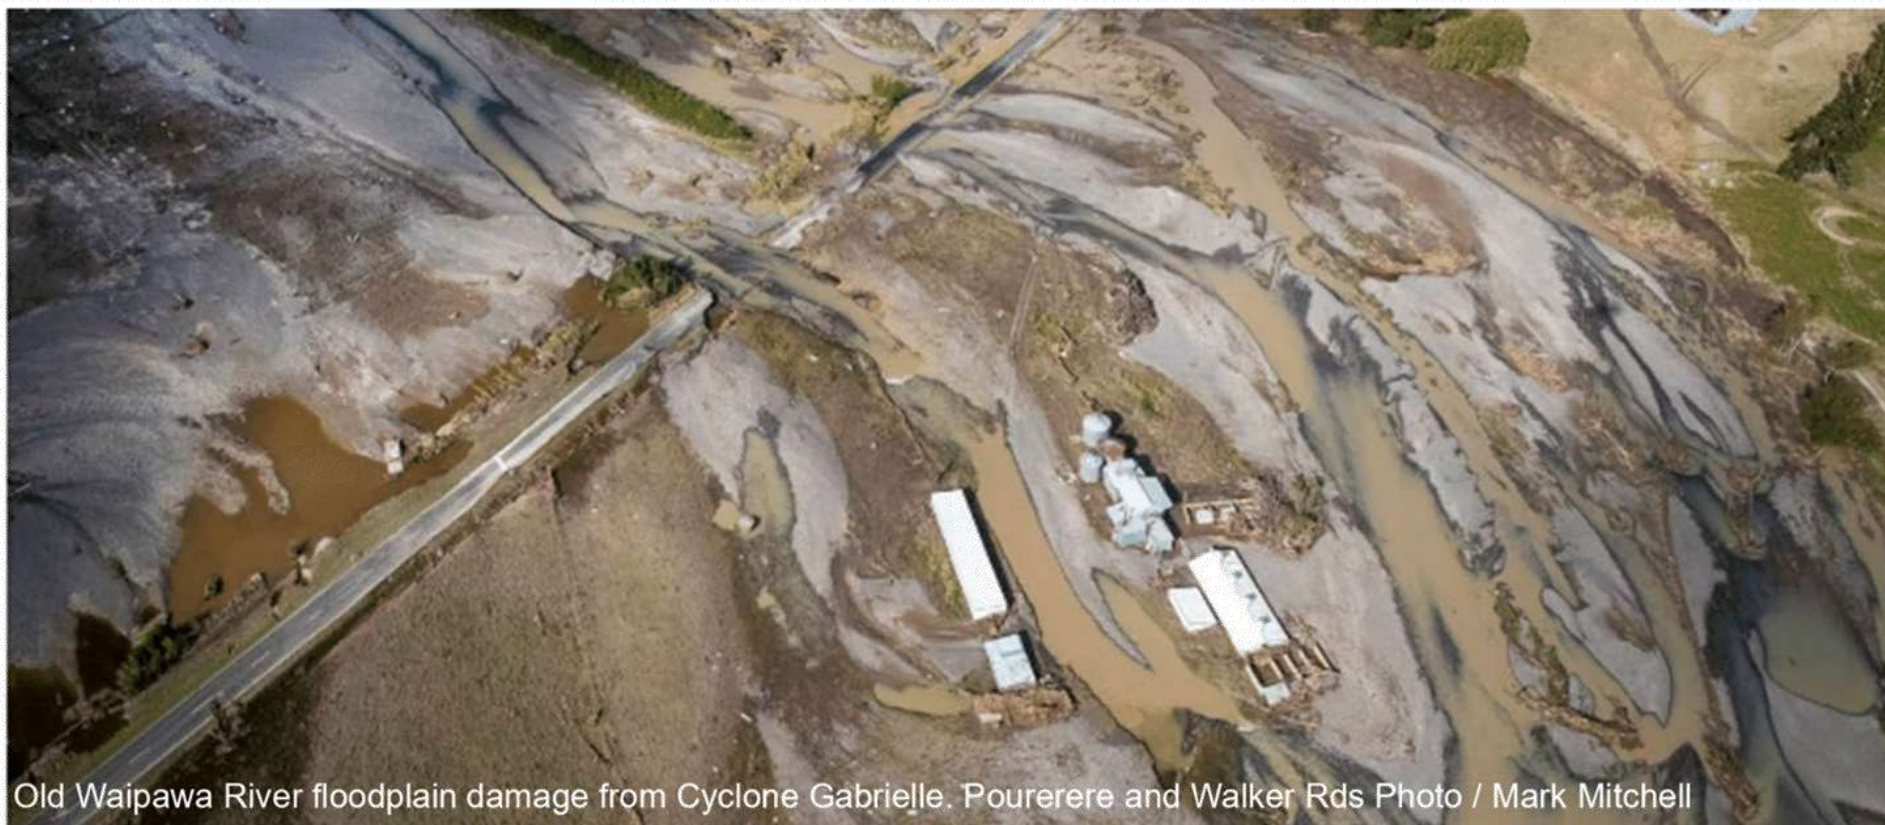
Old Waipawa River floodplain damage from Cyclone Gabrielle. Pourerere and Walker Rds Photo / Mark Mitchell

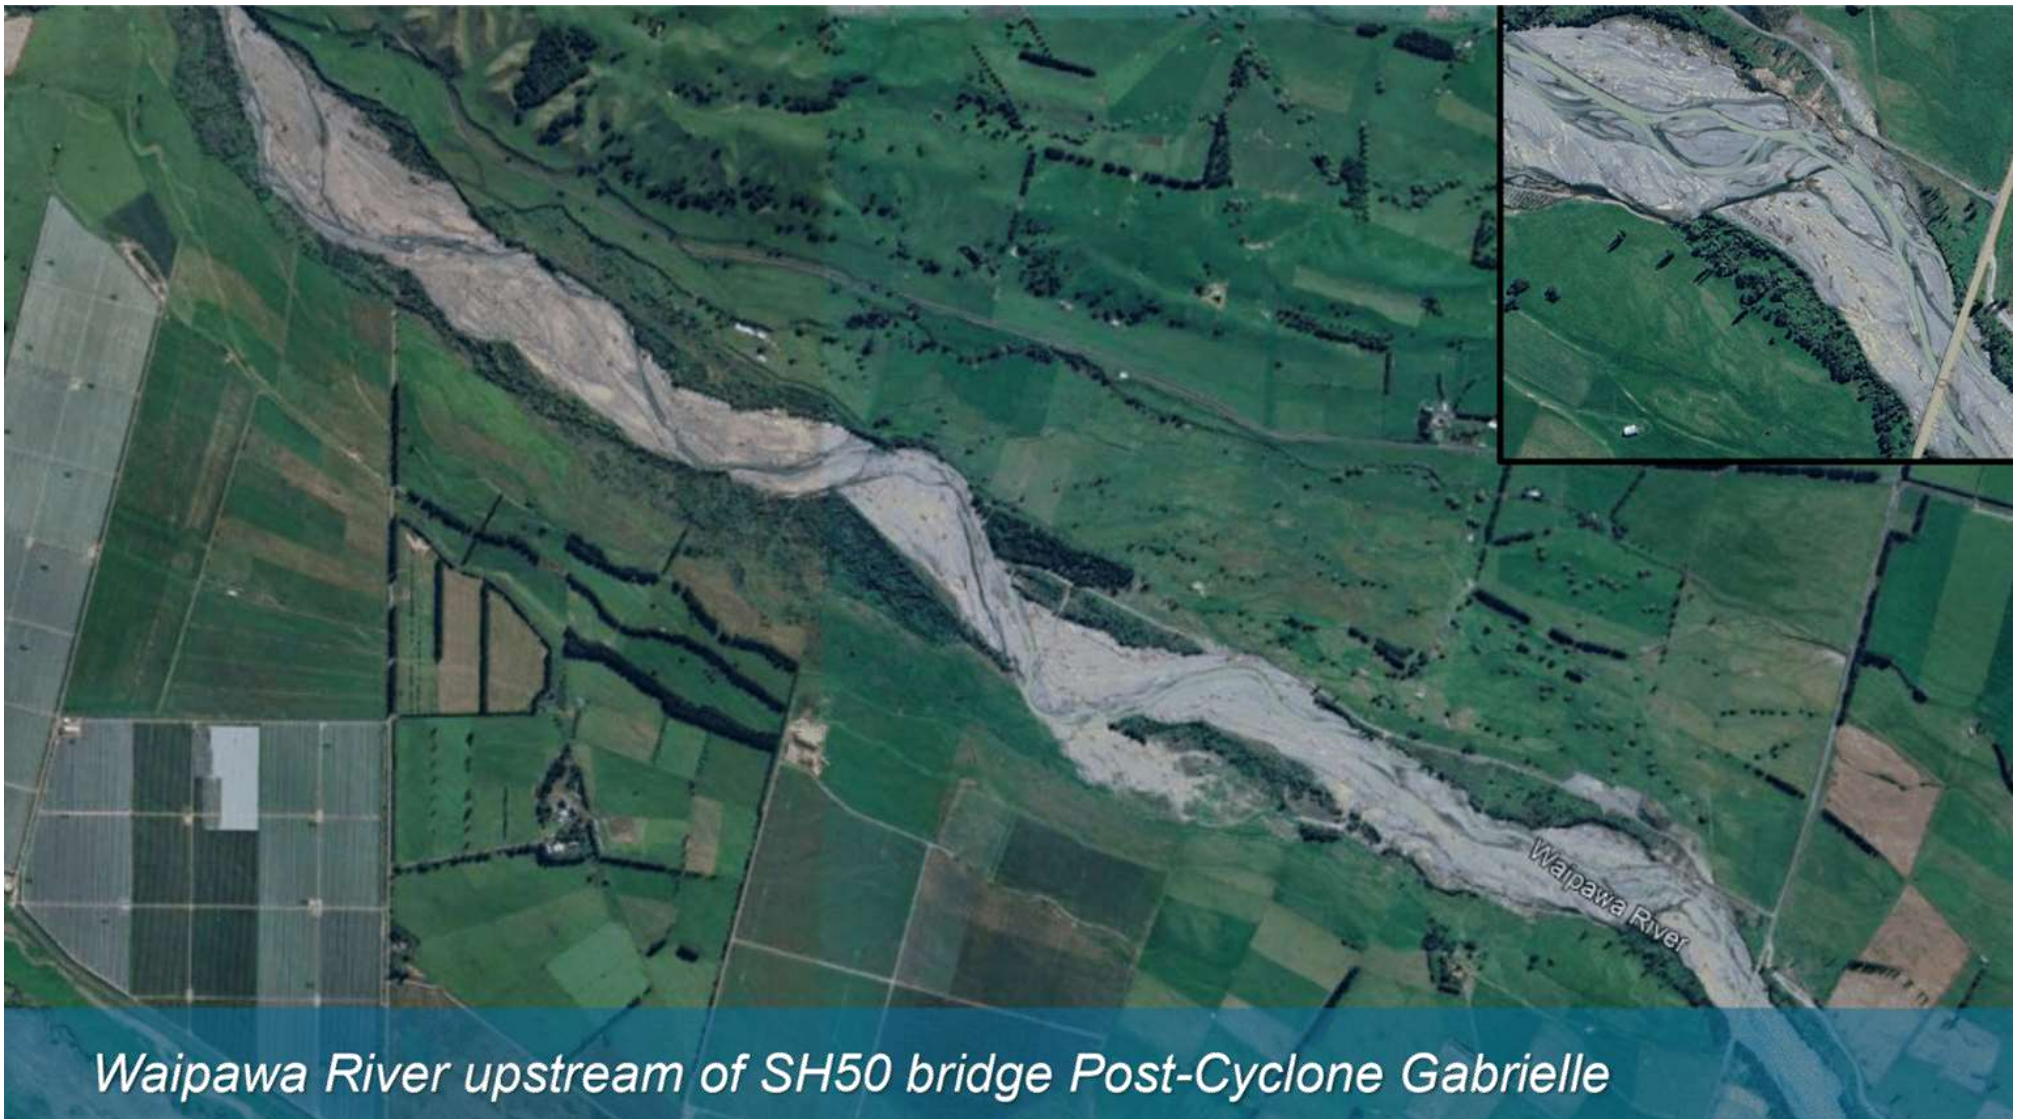
*Waipawa River upstream of SH50 bridge Post-Cyclone Gabrielle*

Observed performance: River scour to edge protection works due to geomorphological processes (and subsequent event scour).

Purpose: Edge protection was training/constraining river to protected SH50 bridge (which narrows the river).

1. Accept and repair
2. **Extend edge protection and widen buffer zone with fairway modifications upstream to constriction**
3. **Deflection bund on true left with heavy armour u/s of bridge (concentrates flow & scour under the bridge)**
4. **Extend bridge/secondary flowpath and remove/reduce narrowing at bridge (Needs discussion with NZTA)**

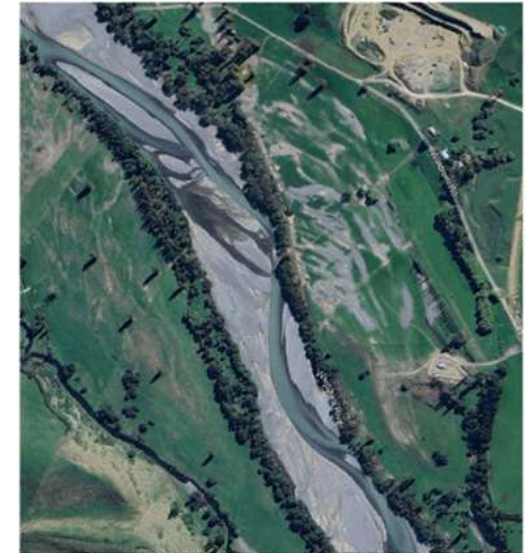
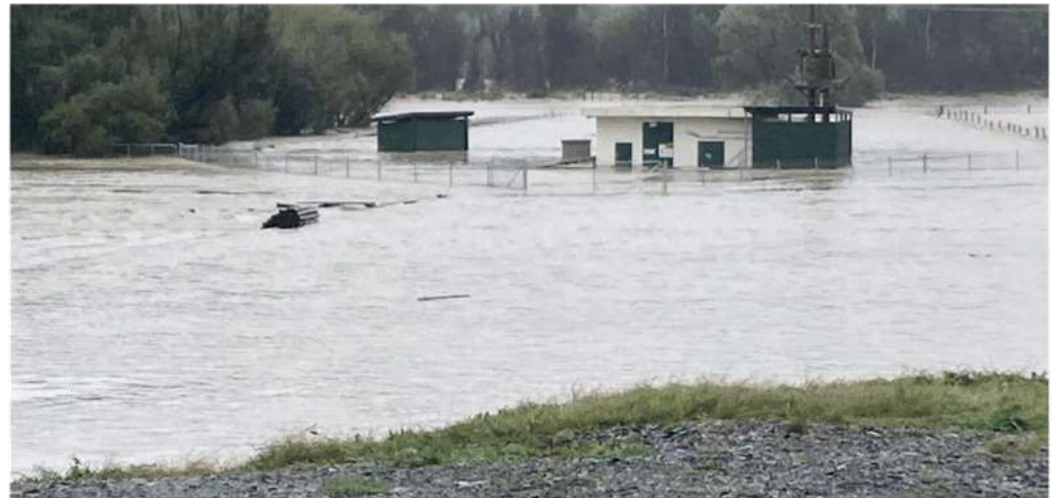
Observed performance: Stopbanks overtopped flooding water treatment plant.

CHB stopbanks, understood to be ~ 20 year ARI standard

1. Rebuild to previous
2. Abandon and build new bunds around plant
3. Relocate water treatment plant to high ground.

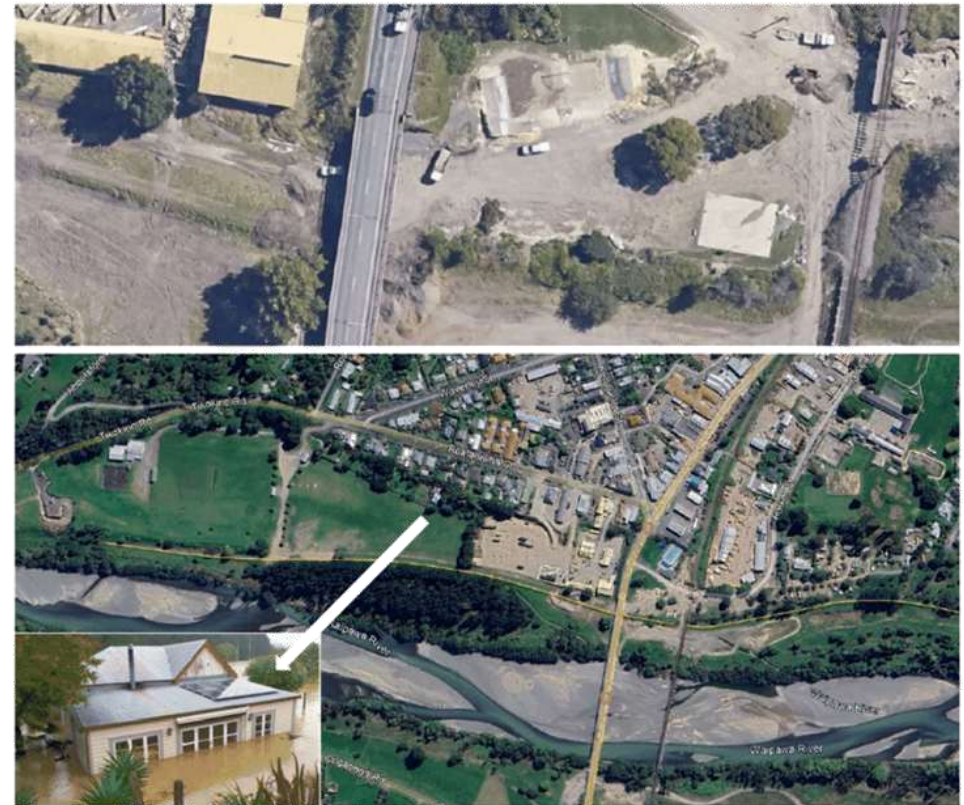
Observed performance: Stopbanks overtopped at Coronation Park and trapped flow led to secondary failure at SH2 flooding lower lying areas including the school.

Modelled performance: Reinstated stopbanks overtop in 250 year ARI design event.

1. Rebuild to previous and accept (rapid rebuild)
2. **Modify stopbanks to provide better resilience (higher stopbanks with cutoffs at SH2 bridge)**
3. Allow overflow at Coronation Park and purchase affected properties.
4. **Excavate gravel bed in this area to increase flood capacity (ongoing maintenance costs)**

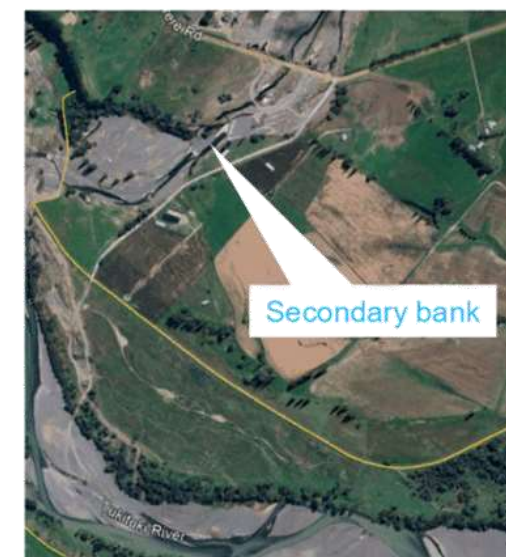
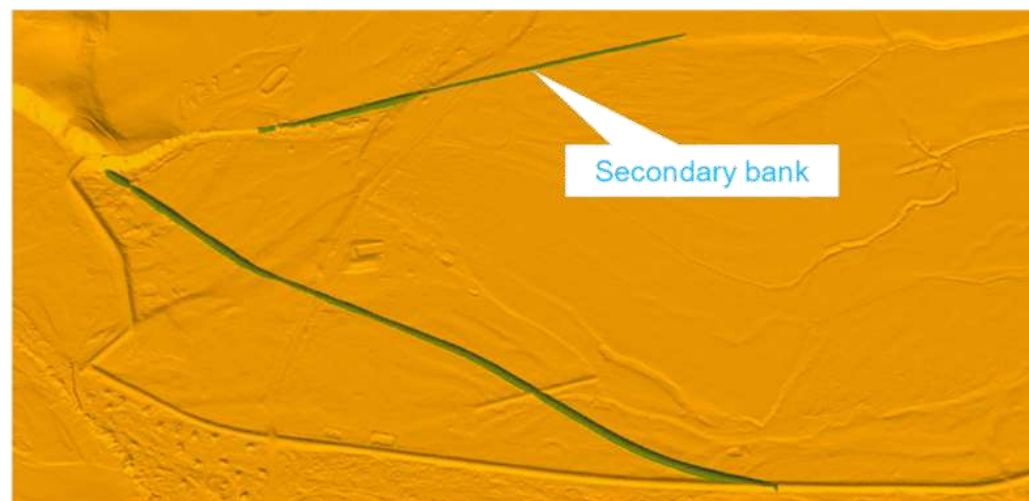
Observed performance: Failure of stopbank due to toe scour. Minor overtopping predicted by model in Cyclone Gabrielle (if had not failed prior)

Options include:

1. Repair to near previous (rapid rebuild) and accept minor LoS/overdesign event flooding
2. **Upgrade with scour/edge protection and landside filter protection (+ increased crest)**
3. Improve geometry with realigned stopbank.
4. **Secondary/replacement stopbanks further back (allow farmland to flood in larger events)**

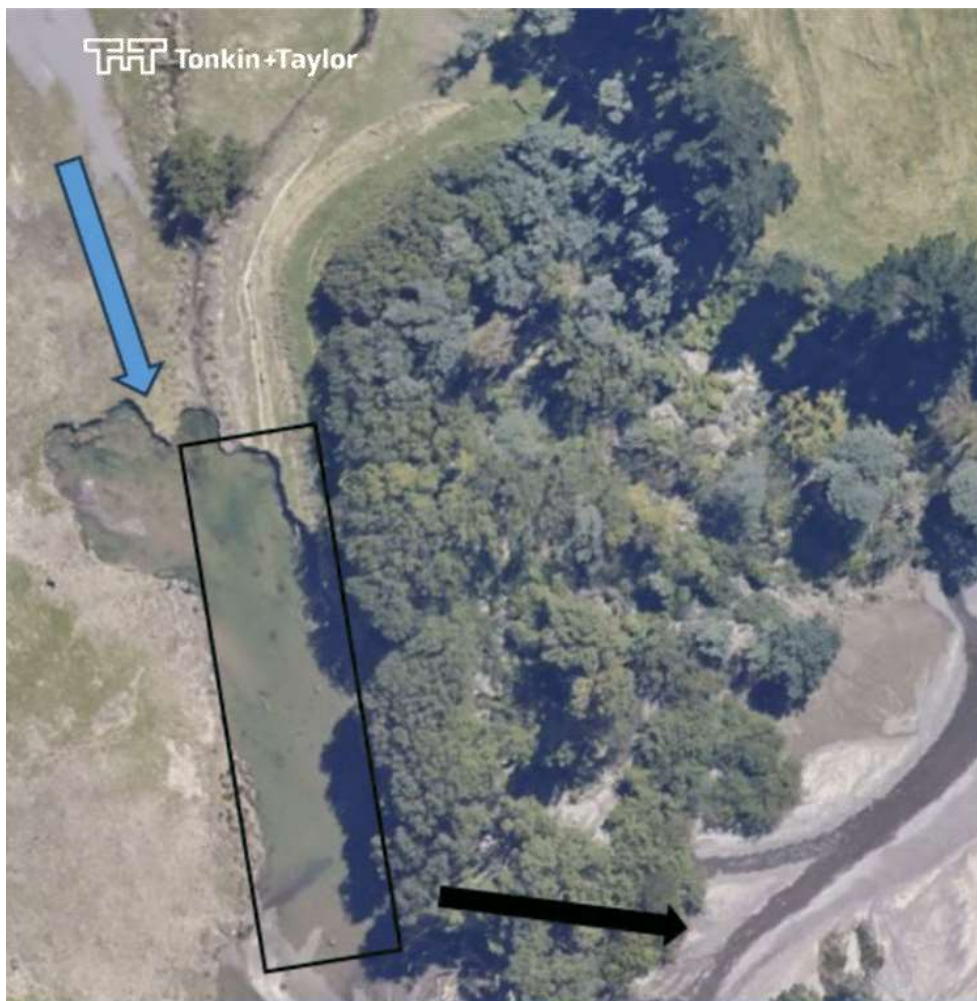
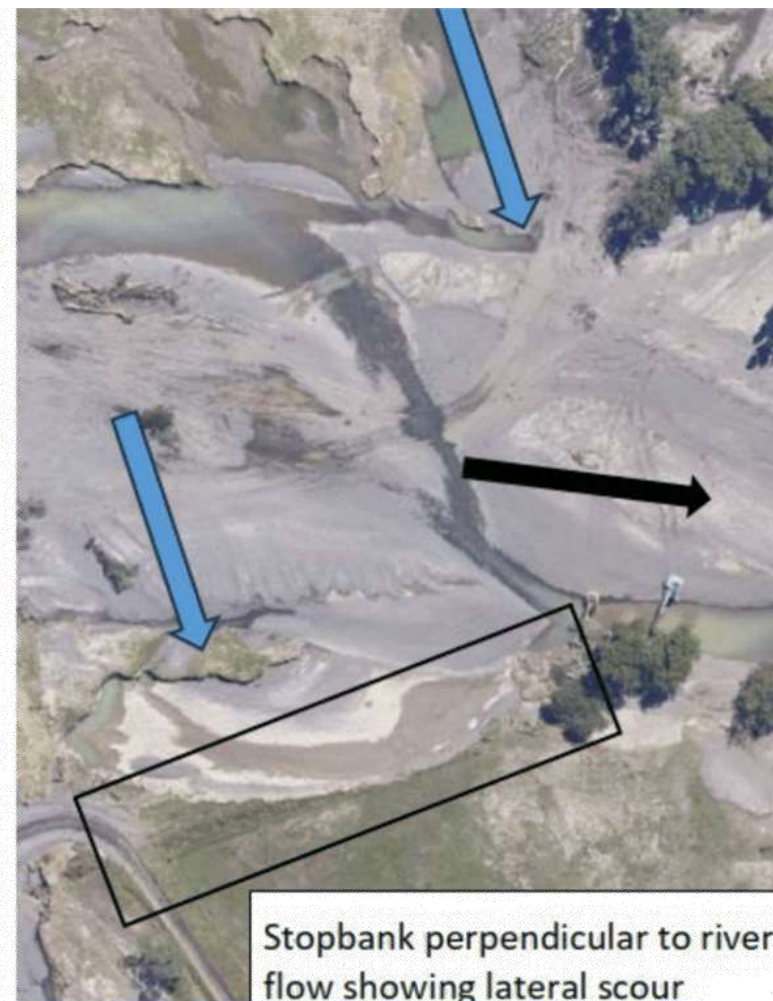
*Walker Rd failure mechanism (lateral erosion of riverside toe)*

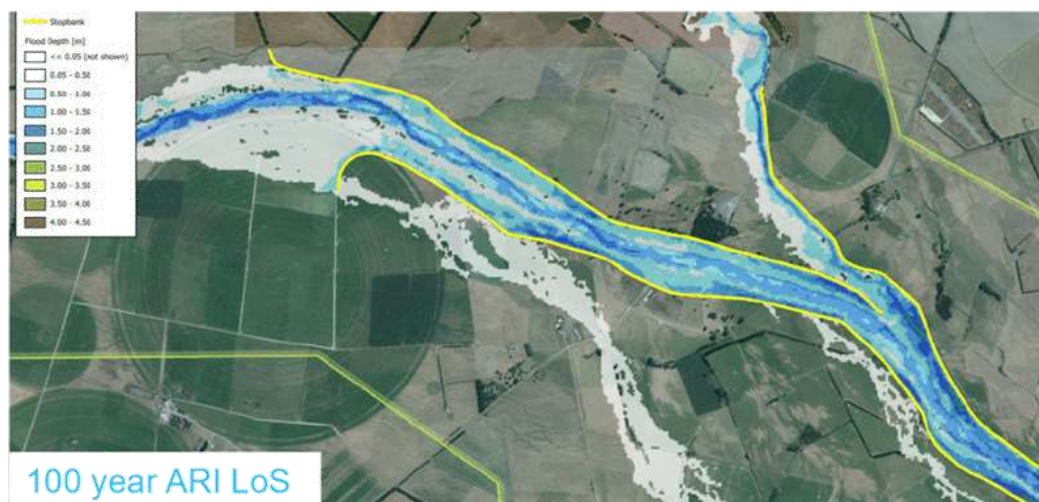
Observed performance: The stopbanks on the true right of the Tukituki River started to outflank and overtop in Cyclone Gabrielle.

Options include:

1. Increasing the stopbank height and extents on true left
2. Allowing overdesign flows in this area (noting large area impacted)
3. River is perched above surrounding land by several m – gravel abstraction in narrow corridor + long term gravel management to increase flood capacity.

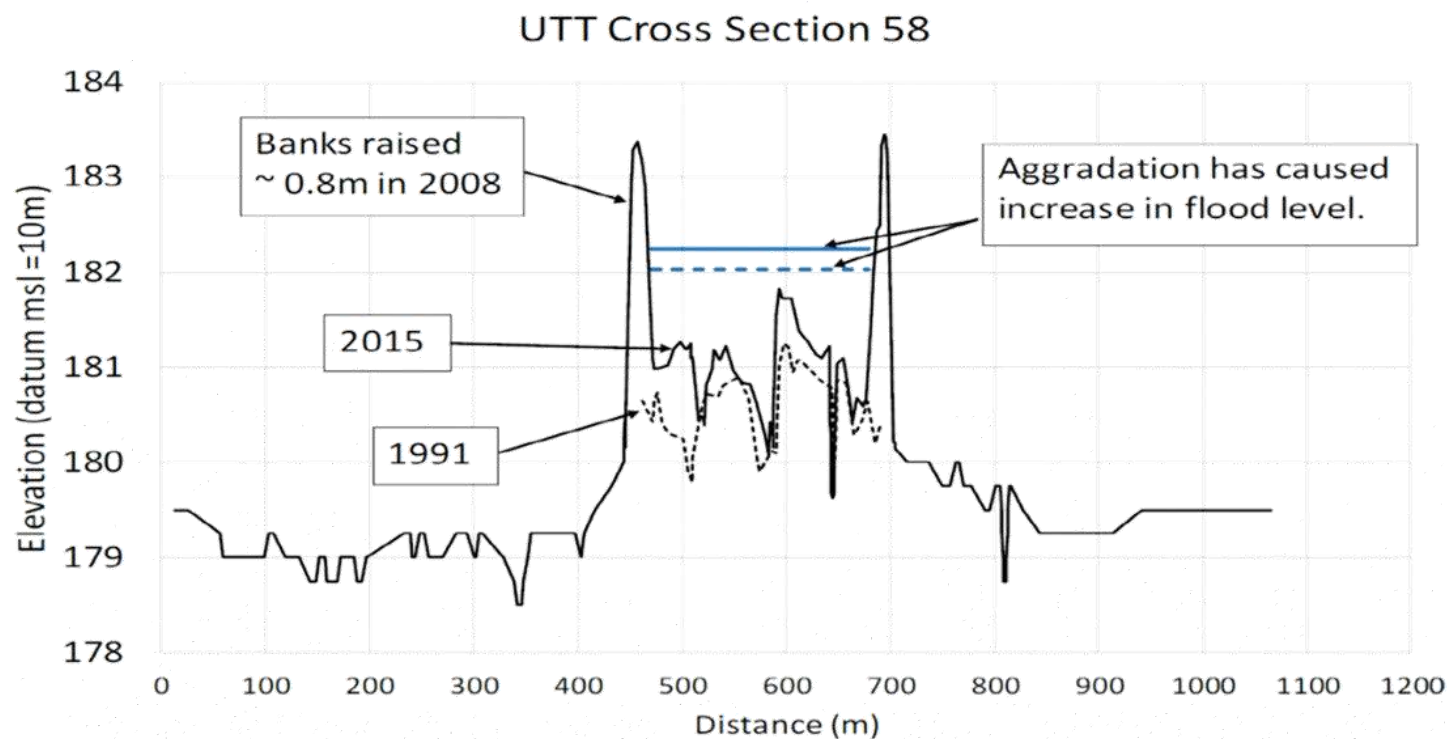
*Gravel aggradation – Perched river reaches on the Tukituki and Waipawa Rivers*
